Recreational Residence Aquatic Resource Assessment

Zigzag Ranger District
Mt. Hood National Forest

Duane Bishop and Todd Parker
February 23, 2009

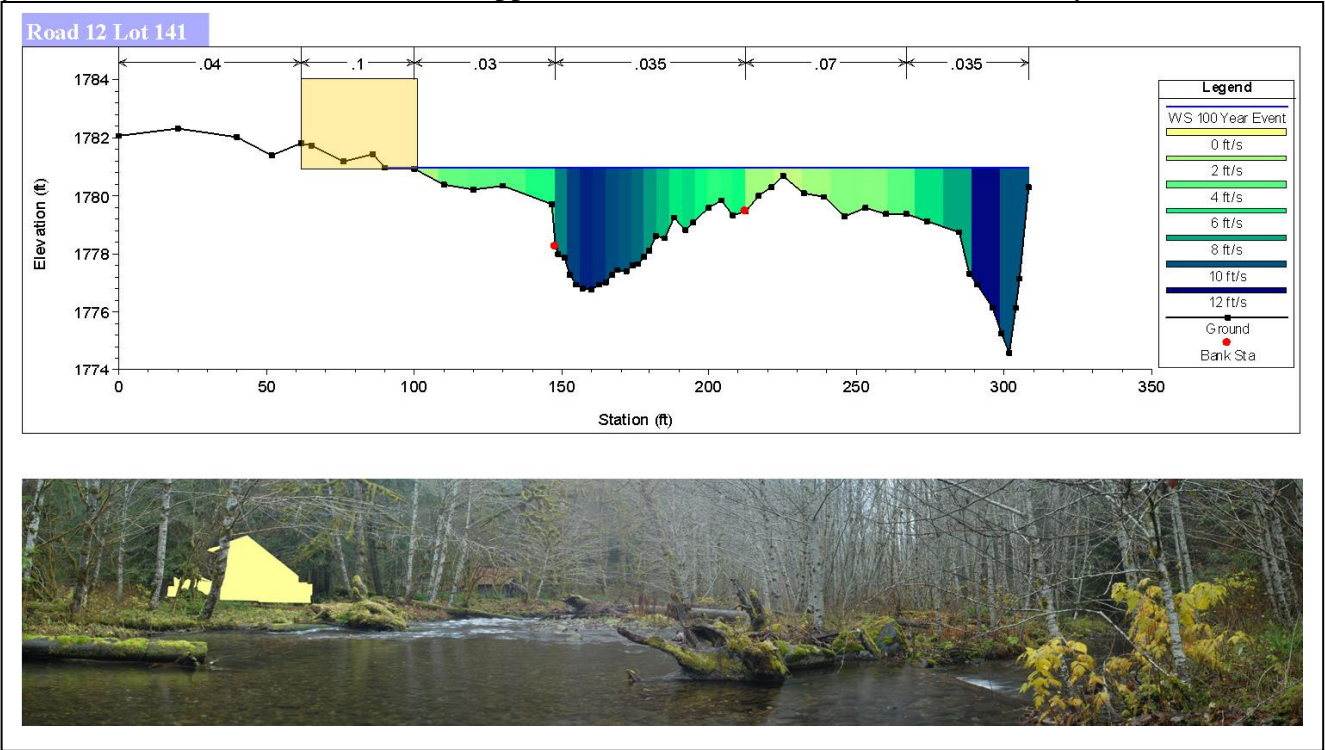
There were 12 sites evaluated with individual HEC-RAS analyses based on cross sections adjacent to structures of concern. Figure 7 details the HEC-RAS output for Lot 141 showing the 100-year flood elevation, water velocity associated with the 100-year flood elevation, and the location of the structure of concern. The accompanying panoramic photo details the site where the cross section was measured. Table 2 displays findings for individual HEC-RAS analyses for the Cool Creek Tract.

Figure 7. Site-specific HEC-RAS analysis for lot 141 representing estimated water velocity at the 100-year flood elevation for Still Creek. Approximate location of the cabin is shown in yellow.

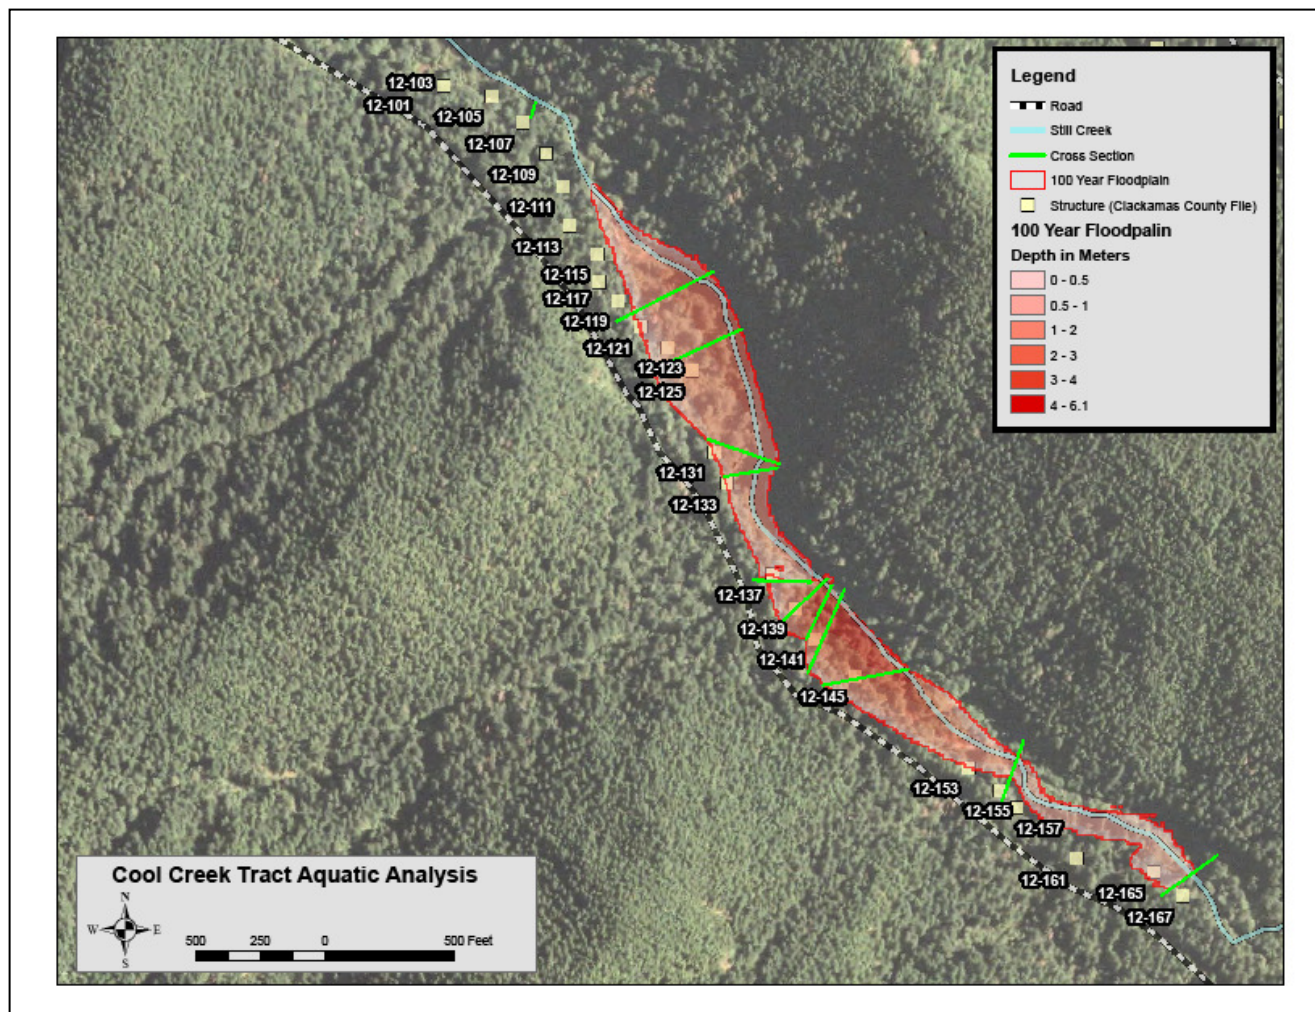
Figure 8 is a GEO-RAS summary of the 100-year floodplain within the Cool Creek Tract, depicting estimated river depth during a 100-year flood event. The summary does not detail the floodplain at lot 167 because there was no channel cross section established upstream of the lot as required by the model. Based on professional judgment, model outputs and local topography it is believed that lot 167 is within the integrated 100-year floodplain.

Figure 8. Integrated floodplain map for Still Creek and the Cool Creek Tract.

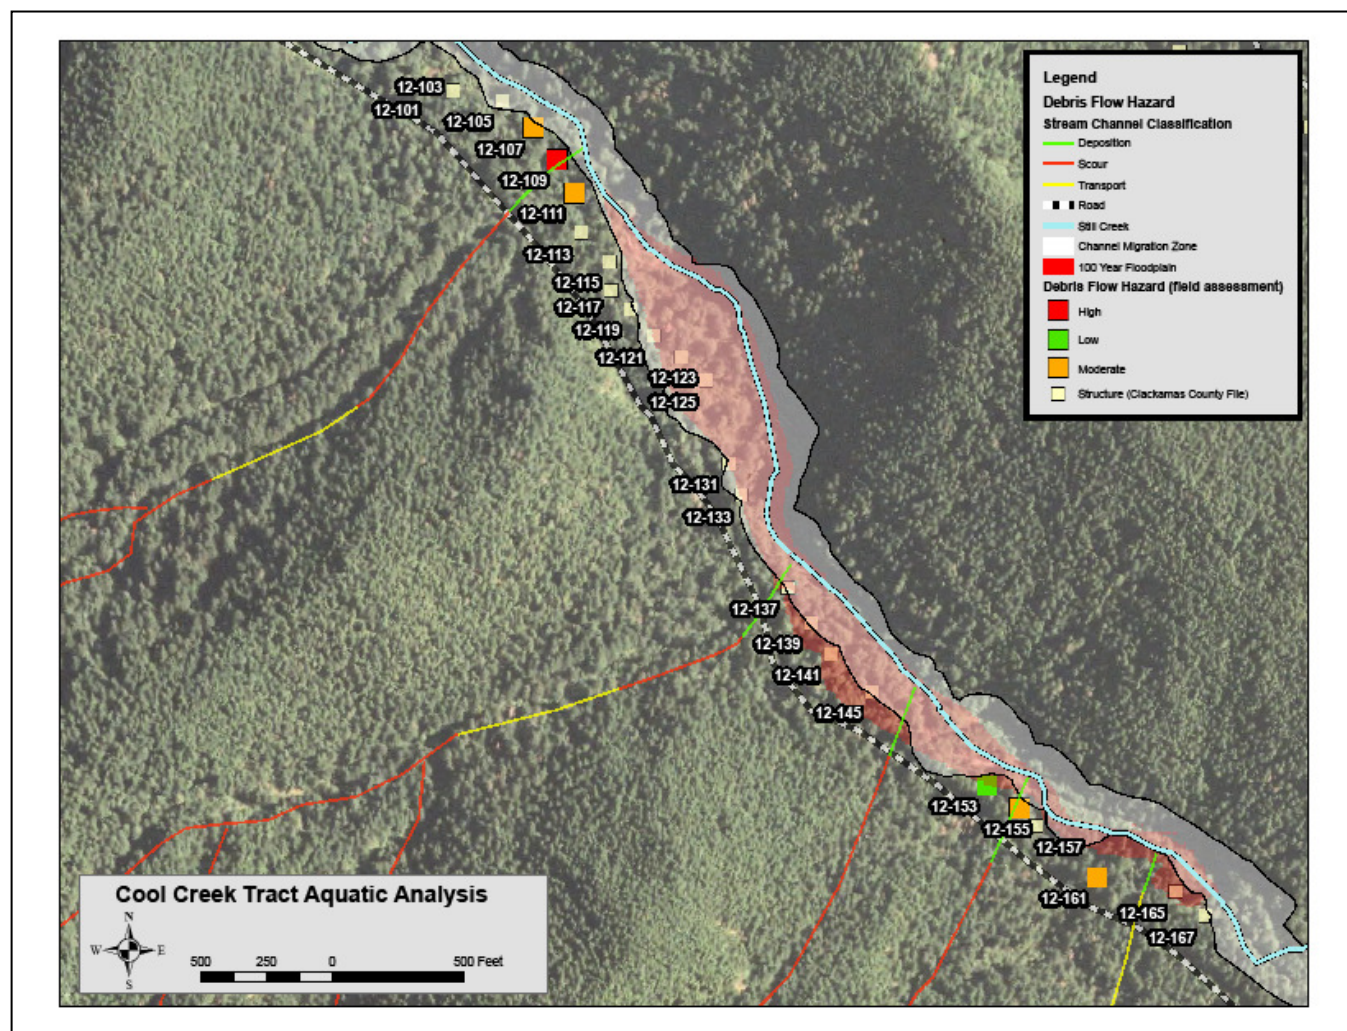
Five “debris flow prone” tributary channels were identified within the Cool Creek Tract. The debris flow prone tributaries originate on the steep slopes of Hunchback Mountain and cross the Cool Creek Tract before reaching Still Creek. Debris flows initiate from hillslope landslides that reach tributary channels or from the mobilization of channel material in very steep confined channels. Usually debris flows initiate during intense rainfall events. LW and sediment also moves downstream from upper Still Creek. Project and permit files, aerial photos, field surveys, GIS mapping, and professional judgment were used to delineate potential hazard areas. Figure 10 displays these findings and their approximate location on the landscape. Critical fluvial processes that are impaired or that are likely impacted by recreational residence occupancy of the floodplain and or debris flow zone are as follows:

- Delivery of LW and sediment to Still Creek and its associated floodplain
- Interception of debris from tributaries into Still Creek
- Lateral channel migration across the floodplain is limited by constructed dikes
- Moderate to high chances of bank erosion due to changed stand condition, structure and species composition from vegetation management adjacent to the channel and floodplain surface
- Accessibility to and evolution of side channels

Figure 10. Debris flow hazards from tributaries along Still Creek, within the Cool Creek Tract.

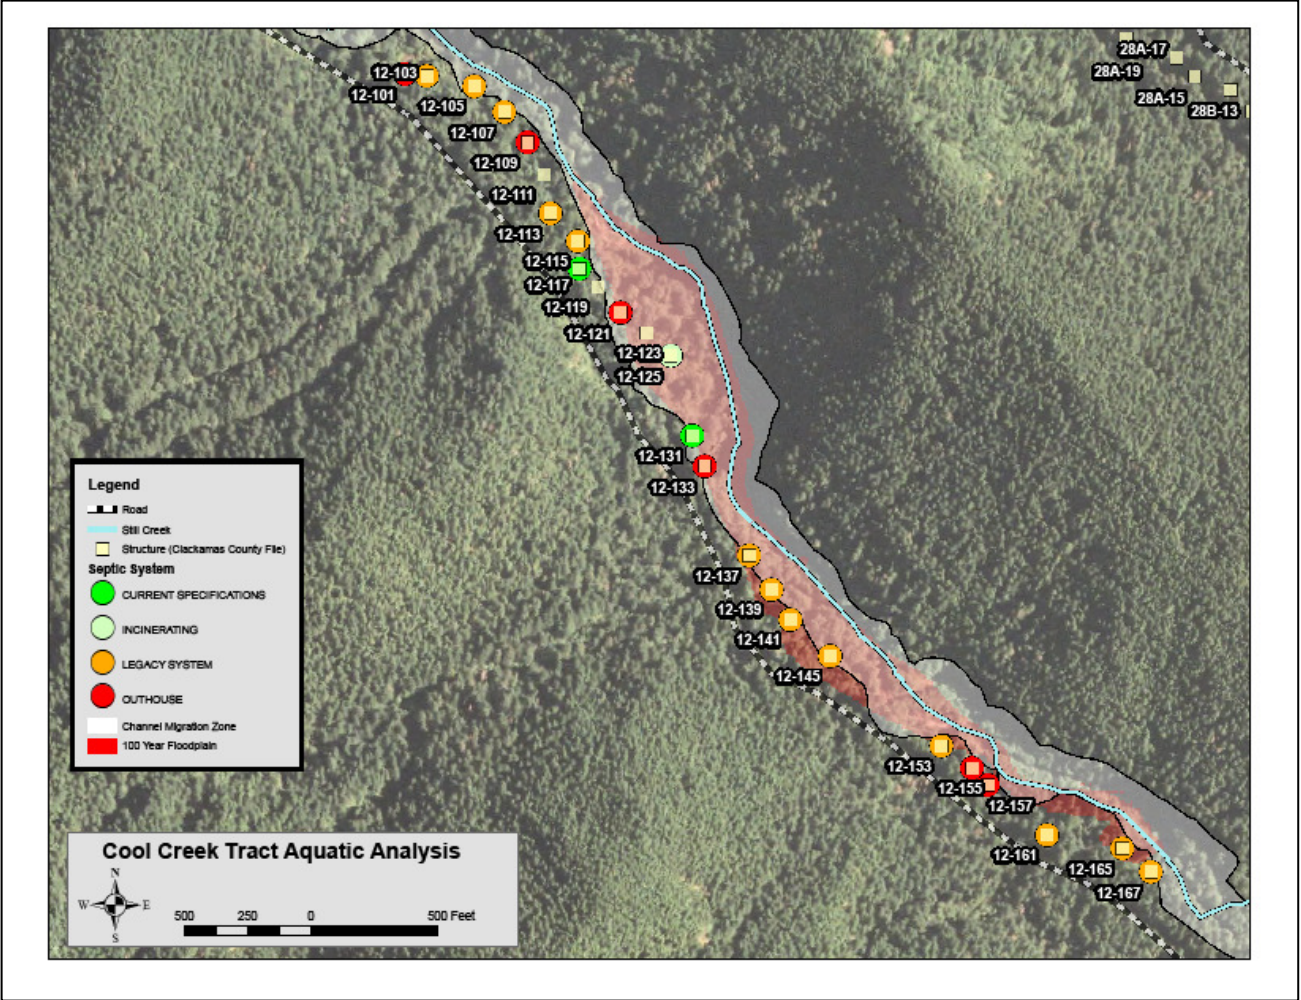
Substandard systems may cause direct delivery of pollutants to the stream system through interaction with hyporheic flow, side channel or main channel flow. An example of this was documented during the November 2006 flood within the Cool Creek Tract; lot number 121 has an outhouse located near the cabin. During high stream flows the pit for the outhouse was full of water to within two feet of the seat, likely from hyporheic flow. For these reasons, it is highly recommended that for those lots located within the floodplain; all septic systems need to be fully self contained.

Figure 14. Known septic systems within the Cool Creek Tract mapped with the channel migration zone and 100-year floodplain.

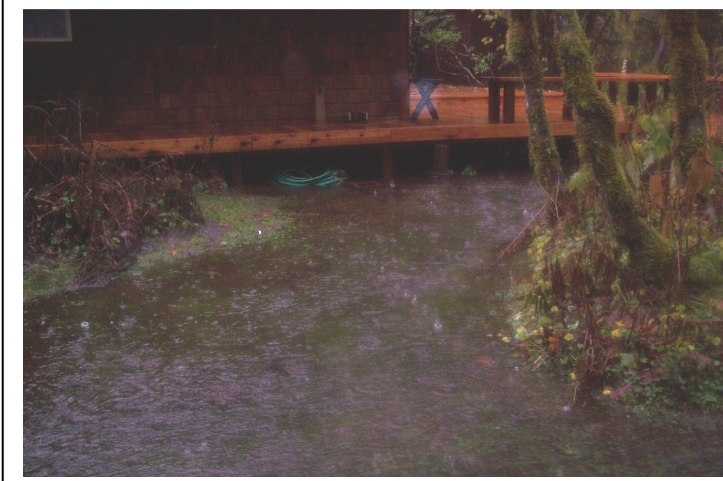
Lot 125 taken 11/07/06. Note water under deck.

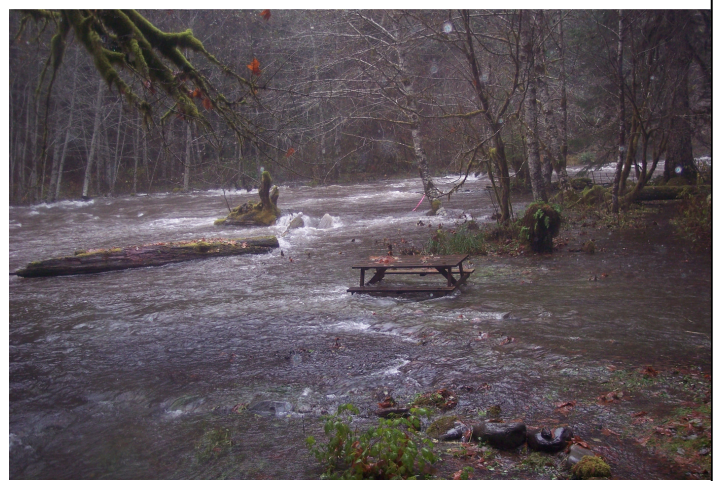
Lot 141 taken 11/07/06. Note water on lot.

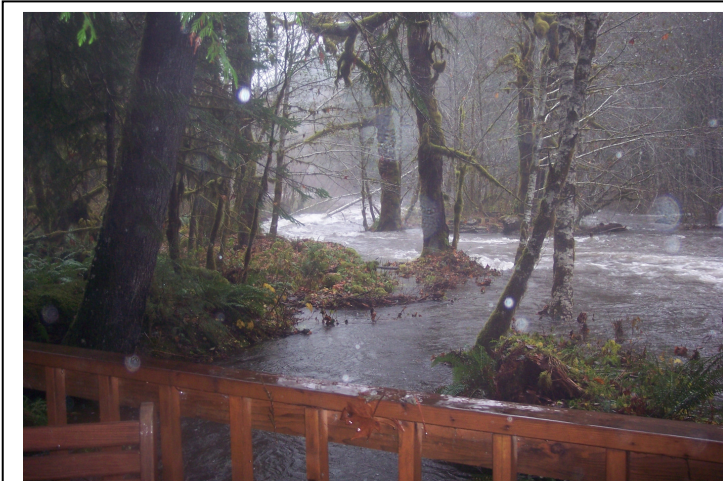
Lot 141 taken 11/07/06. Note water flowing from under the deck and house.

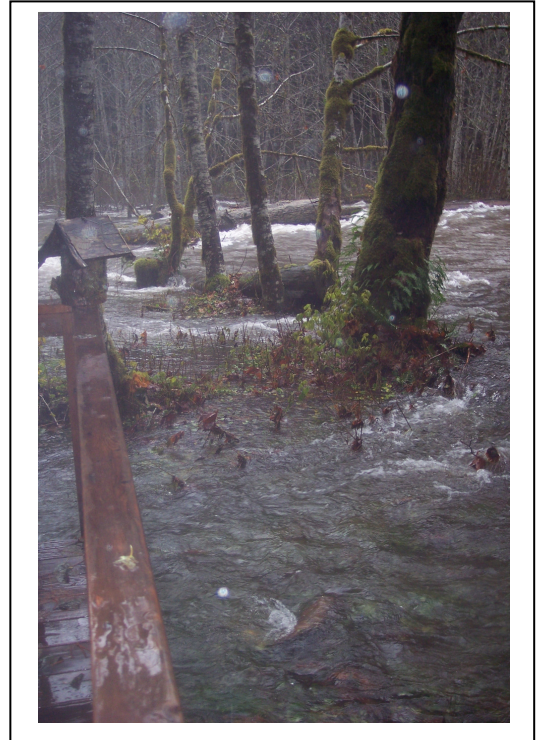
Lot 141 taken 11/07/06. Note water under deck.

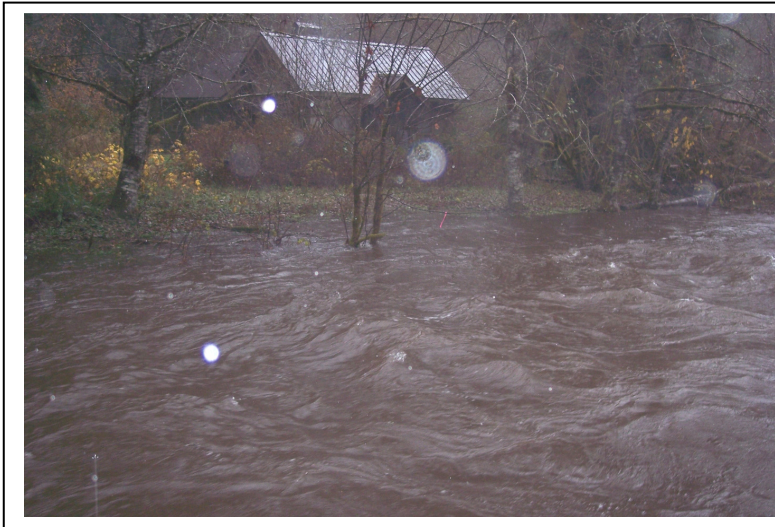
Lot 63 taken 11/07/06. Water near cabin.

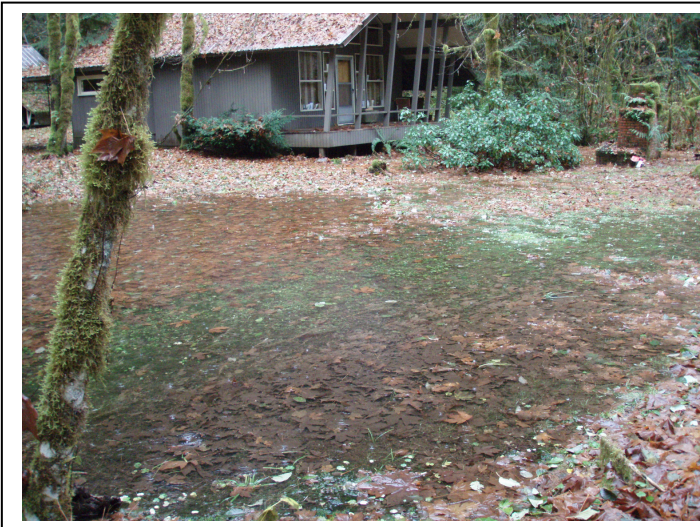
Lot 139 taken 11/08/06. Water in yard.

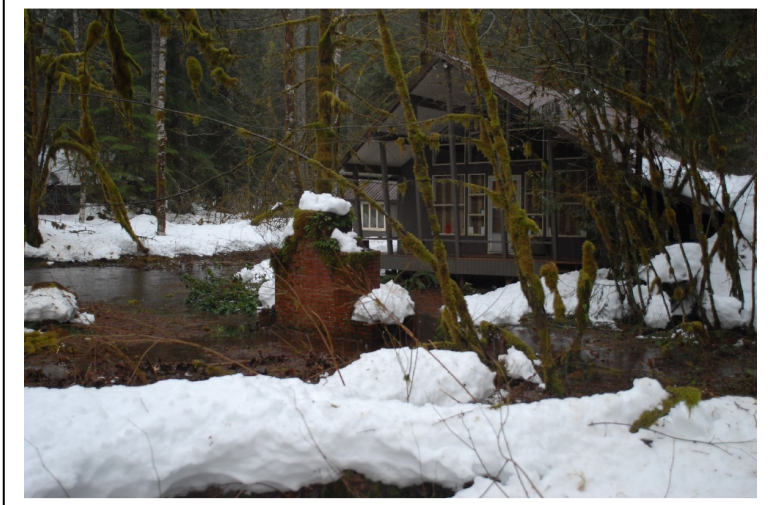
Lot 139 taken 01/08/09 note water on the lot.
